Manhole Inspection Summary

Manhole # S35K__004MH

Insp Date: **9/23/08 11:51 AM**

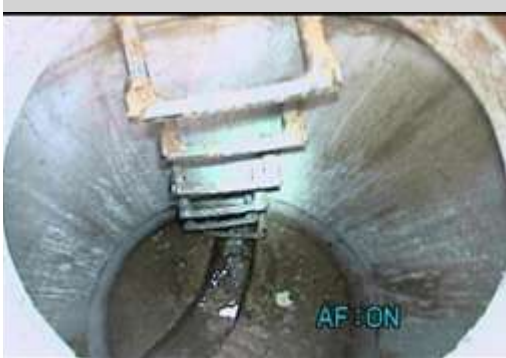
Defect 2

Steps Count: **6** Missing: **0** ☒ **Corroded**

Steps corroded

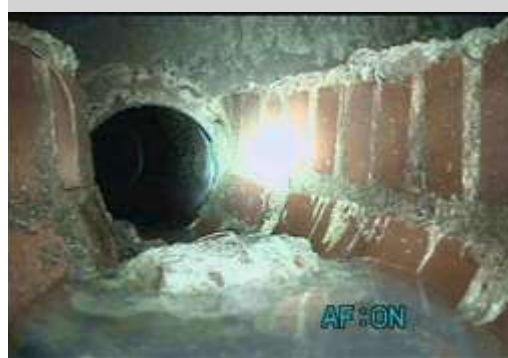
Defect 3

Condition: ☐ Sound ☐ Cracked ☐ Root Intrusion ☐ Deteriorated ☐ Leaks ☒ **Debris**

channel debris

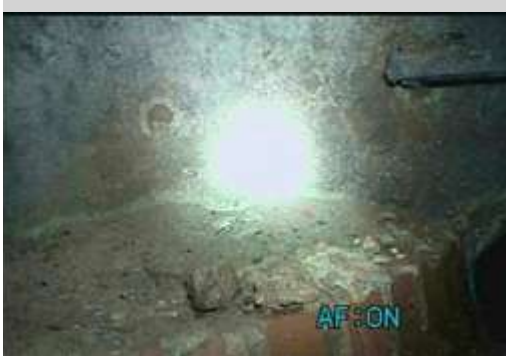
Defect 4

Condition: ☐ Sound ☐ Cracked ☐ Root Intrusion ☐ Deteriorated ☐ Leaks ☒ **Debris**

bench debris

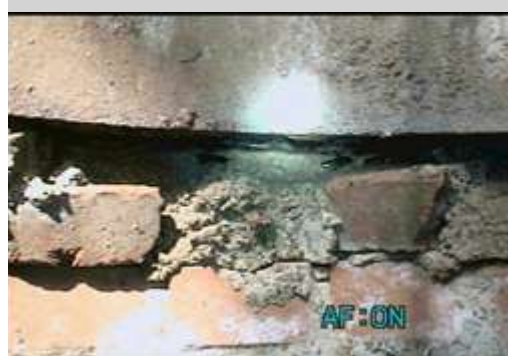
Defect 1

Condition: ☐ Sound ☐ Cracked ☐ Root Intrusion ☒ **Loose Brick** ☒ **Deteriorated**

loose, deteriorated, frame adj

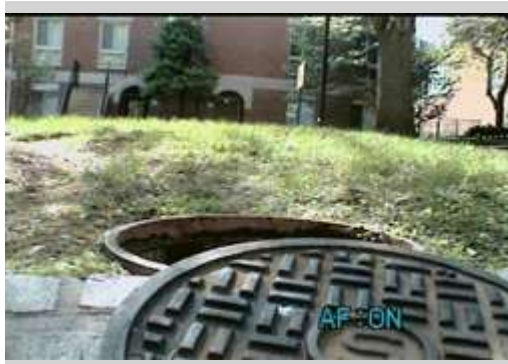
Defect 5

1" cover to grade
